**ALUMINIZED STEEL TYPE 2 CORRUGATED  
STEEL PIPE DURABILITY UPDATE: 1995**

**FIELD PERFORMANCE OF PIPES IN  
SERVICE FOR 42-43 YEARS**

**February 8, 1996**

**LAWRENCE BEDNAR  
SENIOR STAFF CORROSION ENGINEER  
PRODUCT RESEARCH  
RESEARCH & TECHNOLOGY  
AK STEEL CORPORATION**

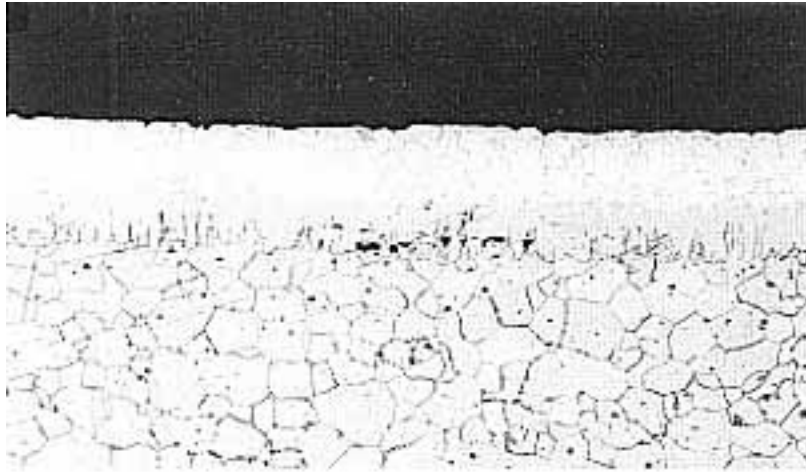
**Morgan County, IL**  
**Invert - Waterside**

**Figure 1A:** Aluminum layer of coating outside pits appears to be essentially undiminished in thickness after 42-43 years. Variation from one pipe location to another and from pipe to pipe appears to be due to known large variation in original thickness characteristic of early production practice. (Mag. = 200X)

Thickness of aluminum layer outside pits undiminished significantly from original.

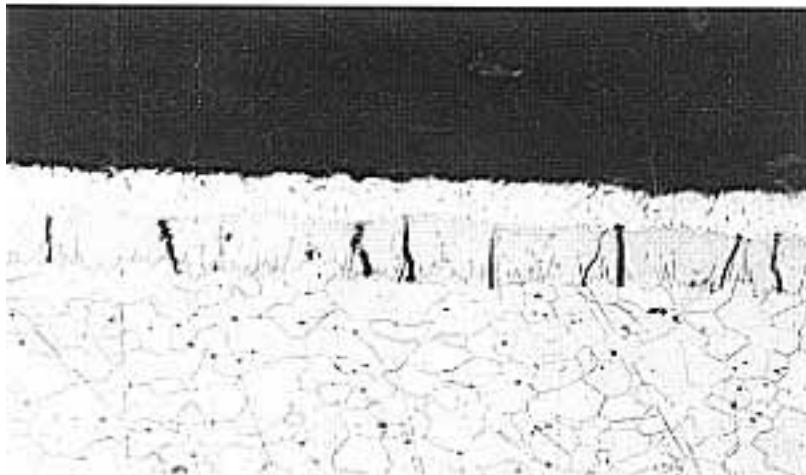
**Lafayette County, MO**  
**Invert - Soilsides**

With highly variable thickness characteristic of early production practice, this is likely original aluminum layer thickness essentially. There is no general attack of aluminum layer that suggests otherwise.

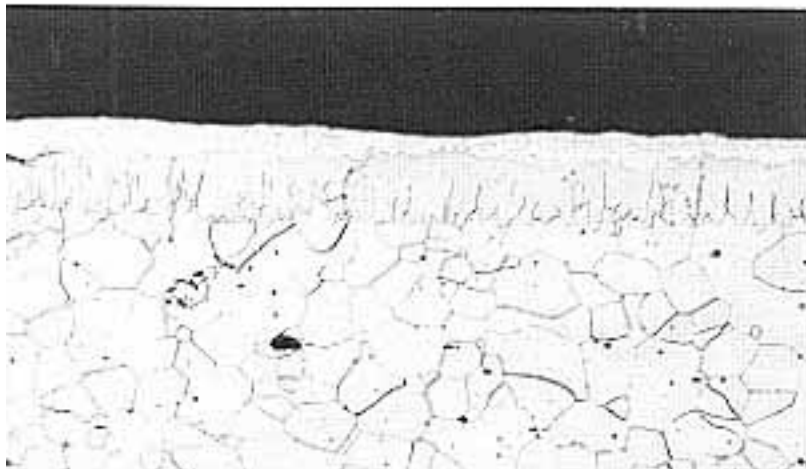
**Montgomery County, TX**  
**Invert - Waterside**

Thinnest Al layer thickness observed - appears to be original undiminished thickness since no surface attack is seen.

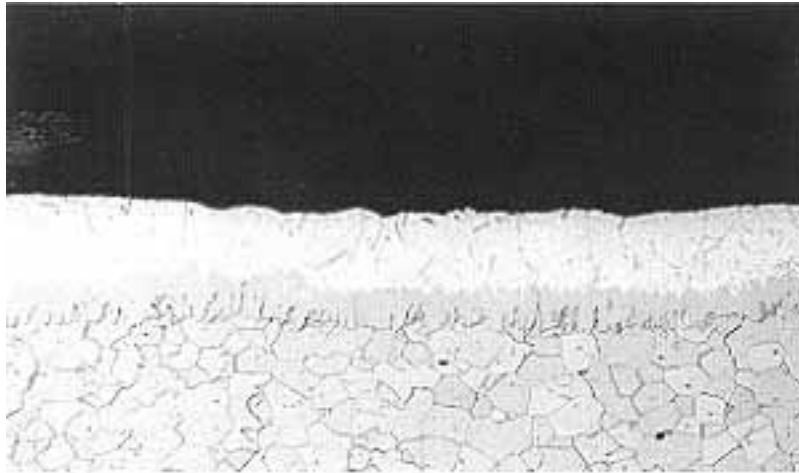
**Snohomish County, WA**  
**Invert - Waterside**

**Figure 1B:** Post-1977 product shows no evidence of aluminum layer deterioration outside incipient pits in the layer after 10 to 15 years in service. Variation in aluminum layer thickness was much better controlled after the 1977 coating technology improvements, but higher than typical thickness is observed on occasion. (Mag. = 200X)

14-year-old material

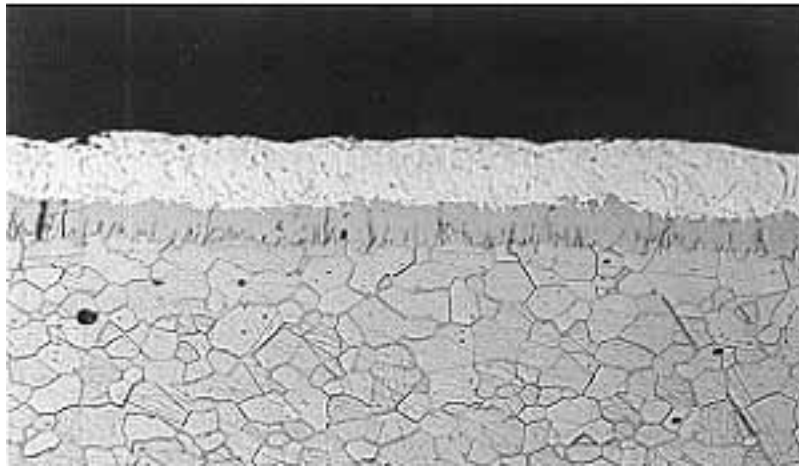
**Penobscot County, ME**  
**Invert - Soilside**

15-year-old material

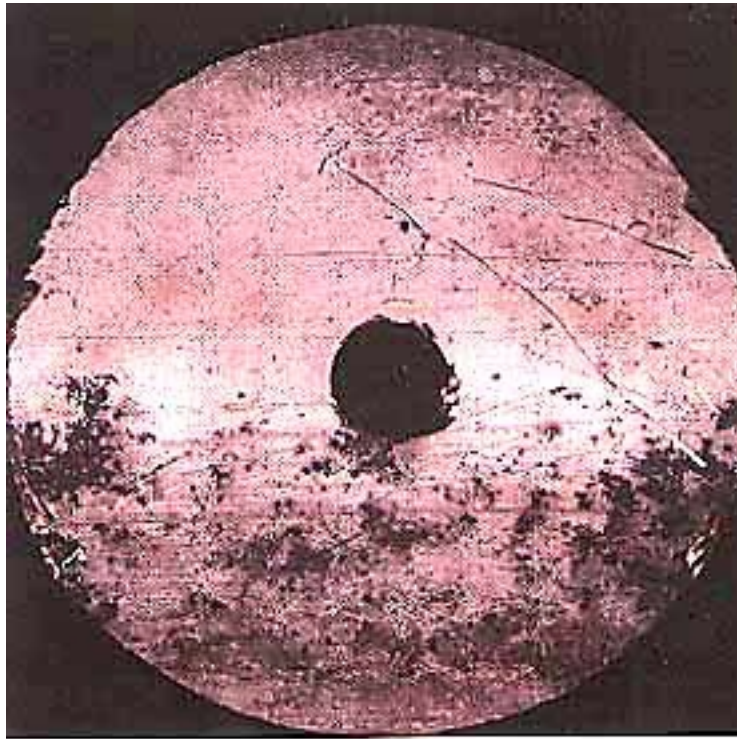
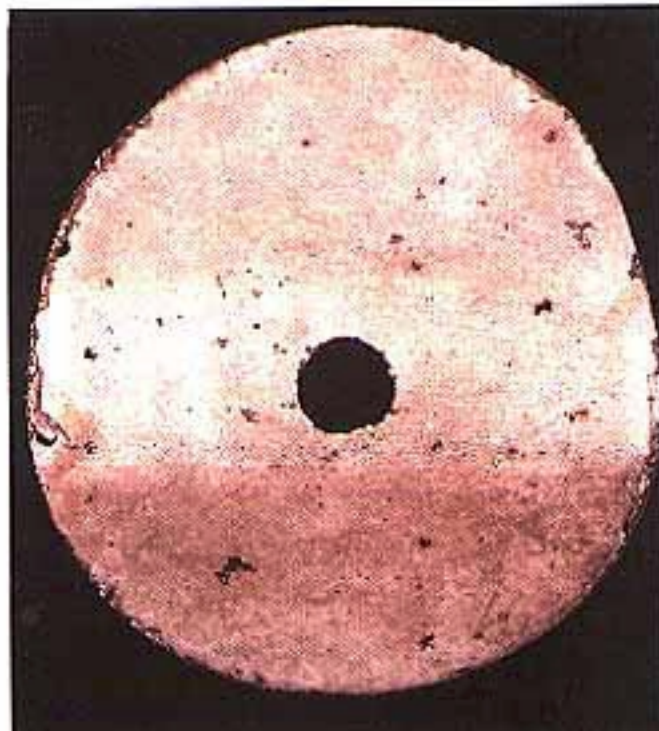
At typical sites, Type 2 showed a range of minor pitting. Among typical sites, pitting was sometimes very minimal, amounting to just scattered localized penetrations of the aluminum layer of the coating and consequent exposure of the Al-Fe intermetallic alloy coating layer (see Figure 2).

**Figure 2:** Pits in the coating Al layer on 42-year-old material that expose the coating intermetallic alloy layer with no further penetration

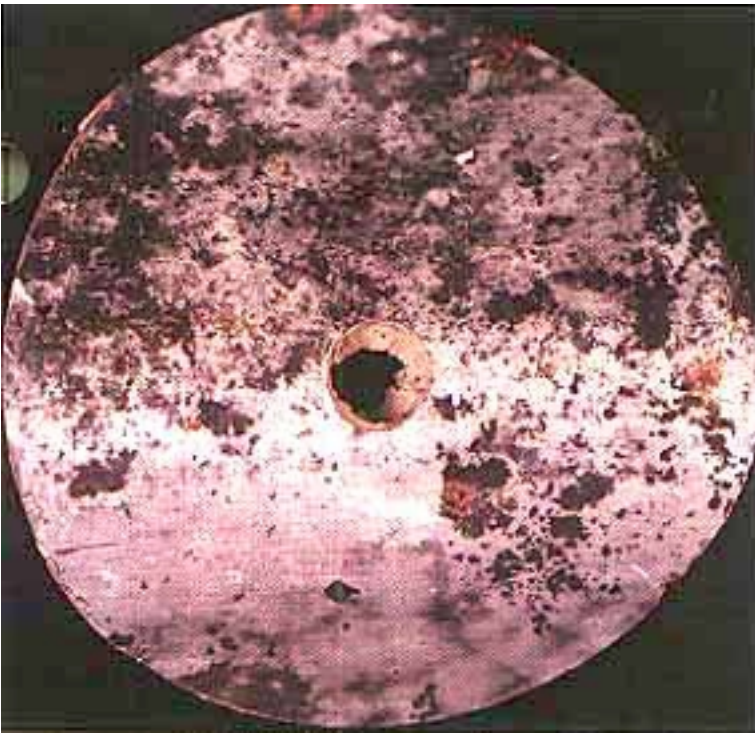
**ALUMINIZED Type 2 - Invert - Waterside**  
Mag. = 2X

At other typical sites, small scattered pits extending into the steel substrate to a degree were observed (see Figure 3). Propagation of pitting in the steel substrate is quite slow in normal environments, judging by comparison of approximate pit depths now and 13 years ago (see enclosed table). It is somewhat difficult to determine pitting progress since the earlier inspection because pitting is scattered and varies in severity with pipe location. Thus pitting on specimens at one pipe location can be significantly different from that at another. Indeed in one extreme case at Snohomish Co., WA, the latest corings did not encompass the soilside pitting observed 13 years ago. However, the overall comparison of pit depths now with those determined 13 years ago indicates that pitting progress overall for the last 13 years has been quite slow. For all sites involving normal environments, perforation at pits would appear to be a very long-term event. Pipe function and structural stability would not be significantly affected when perforation at such pits does occur eventually since pits are typically quite small as Figure 3 illustrates. Two sites (one in DeSoto Co., MS, and one in Lafayette Co., MO) show larger pits than is typical due to some effect of the previously noted excessive alloy-cracking problem associated with older production methods, but this pitting, too, was not indicative of functional or structural problems in the foreseeable future.

**Figure 3**  
Comparative behavior of 42-year-old ALUMINIZED Type 2 and newer galvanized pipe at one of the most severely corrosive sites (located in Tate County, MS)

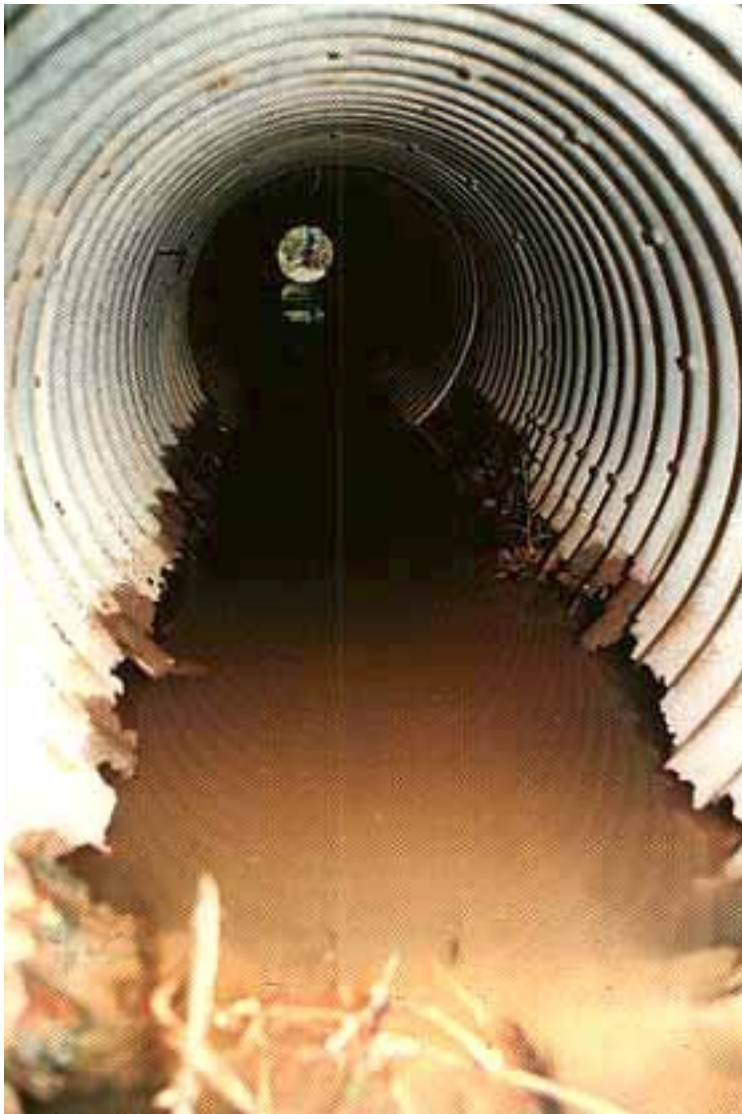
**Galvanized Invert Destroyed**  
ALUMINIZED Type 2 is between two galvanized sections. Galvanized section in foreground is a later road widening addition extending the pipe length without coupling to the Aluminized. The invert of this galvanized section was badly deteriorated when inspected 13 years ago at less than 30-years age.

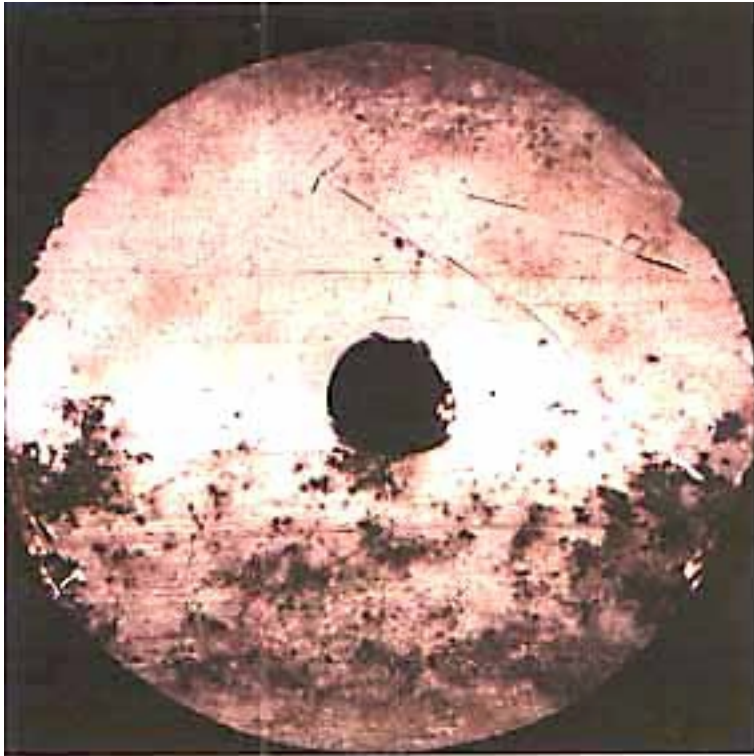
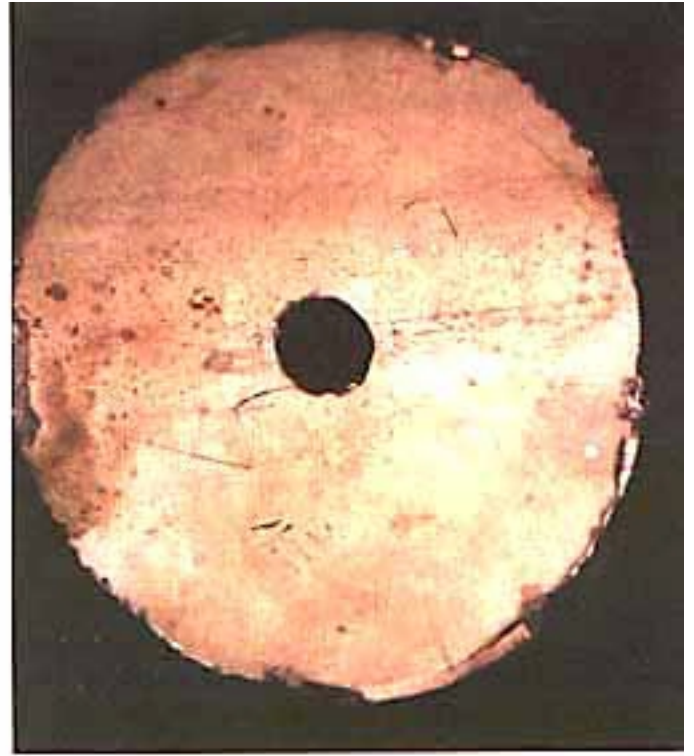
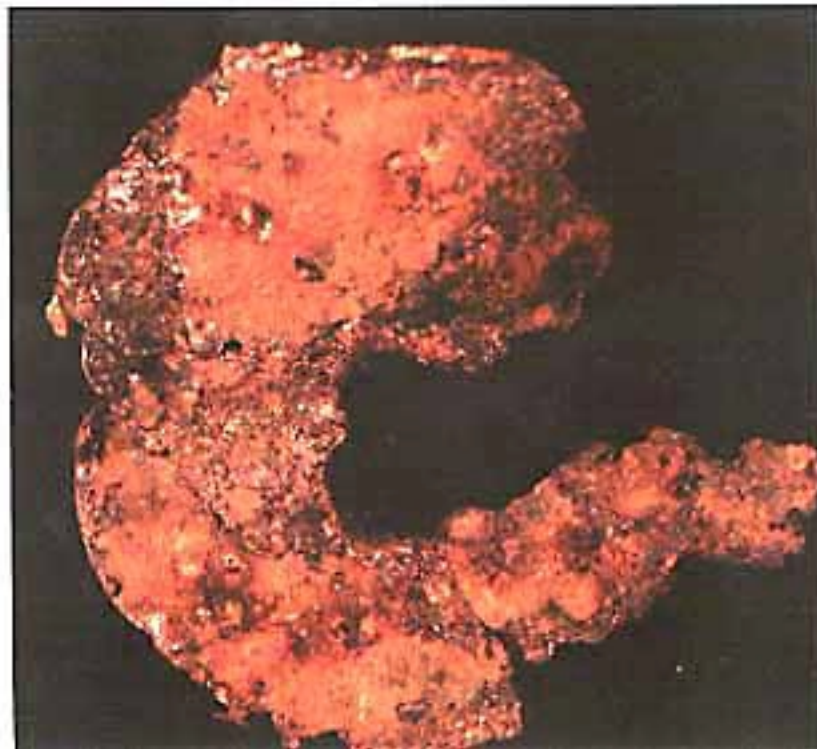
Figures 3-6 illustrate, for those site environments that were most severe for galvanized, the typical comparative condition of Type 2 and galvanized steel. The most widespread severe problem for galvanized steel pipe in the study and throughout the nation as a whole, as various studies have shown<sup>(2, 3, 4, 5)</sup>, is soft and slightly acidic groundwater or surface run-off. At sites with such run-off, the survey results indicate that a very large advantage of the Type 2 material

**Figure 4:** Comparative behavior of 43-year-old ALUMINIZED Type 2 and galvanized pipe in Morgan County, IL

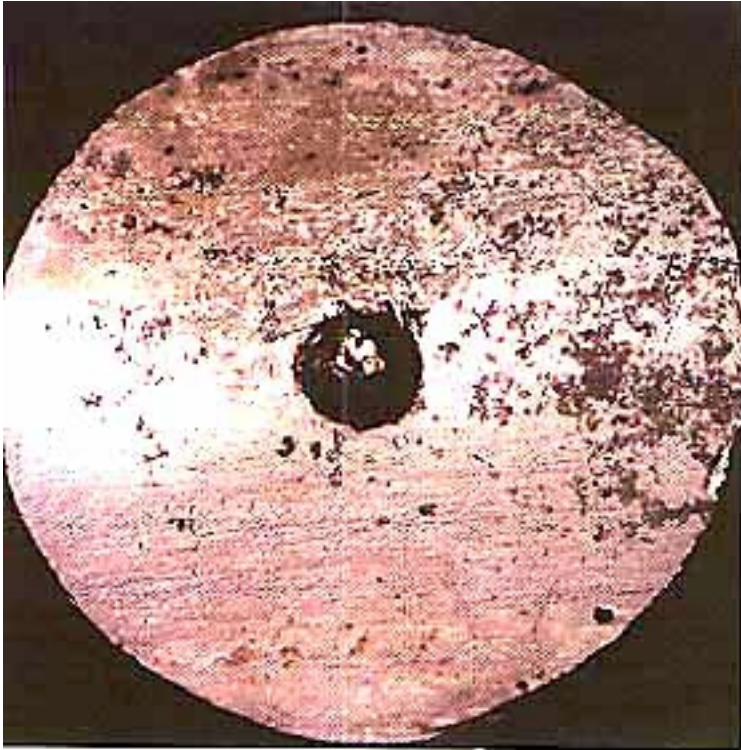
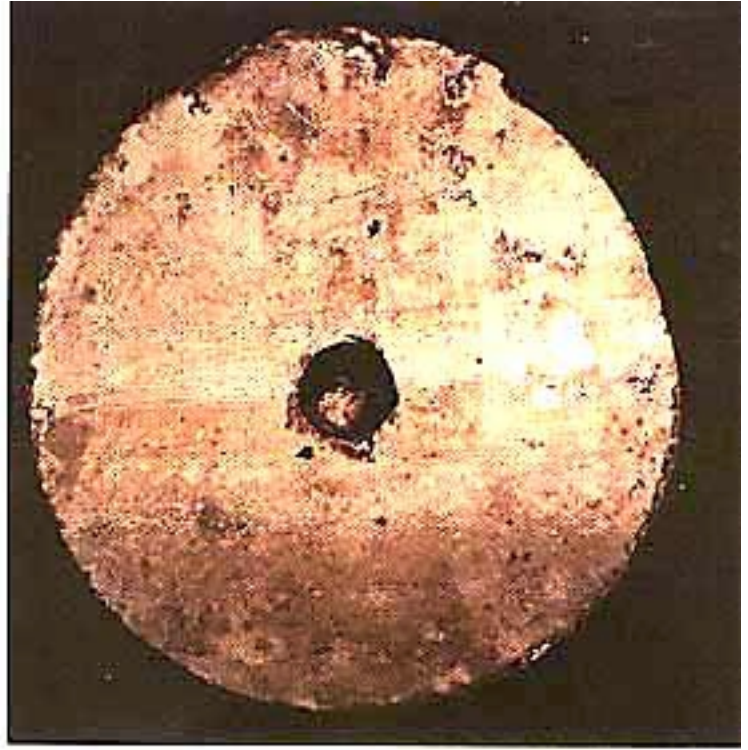
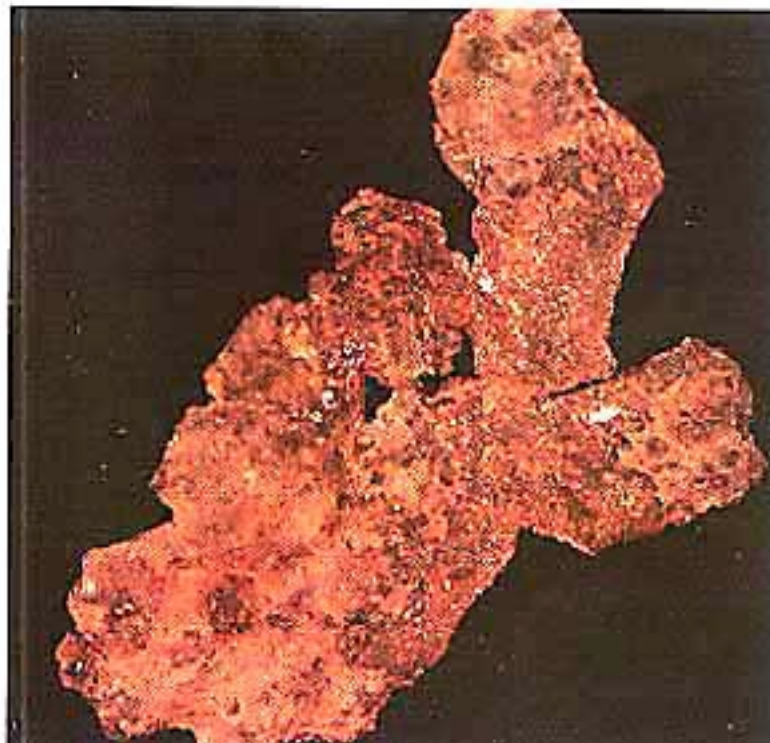
**Figure 5:** Comparative behavior of 43-year-old ALUMINIZED Type 2 and galvanized pipe in Lafayette County, MO

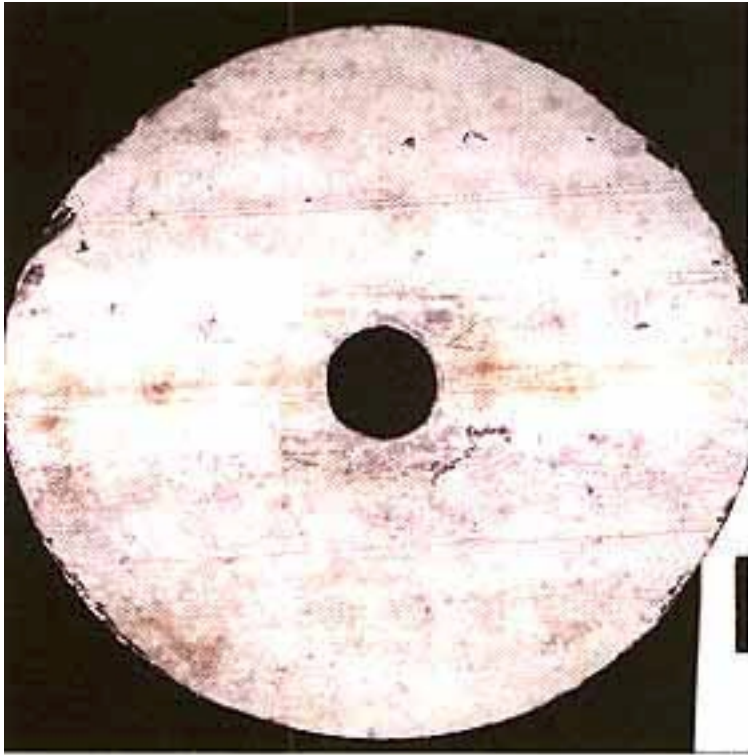
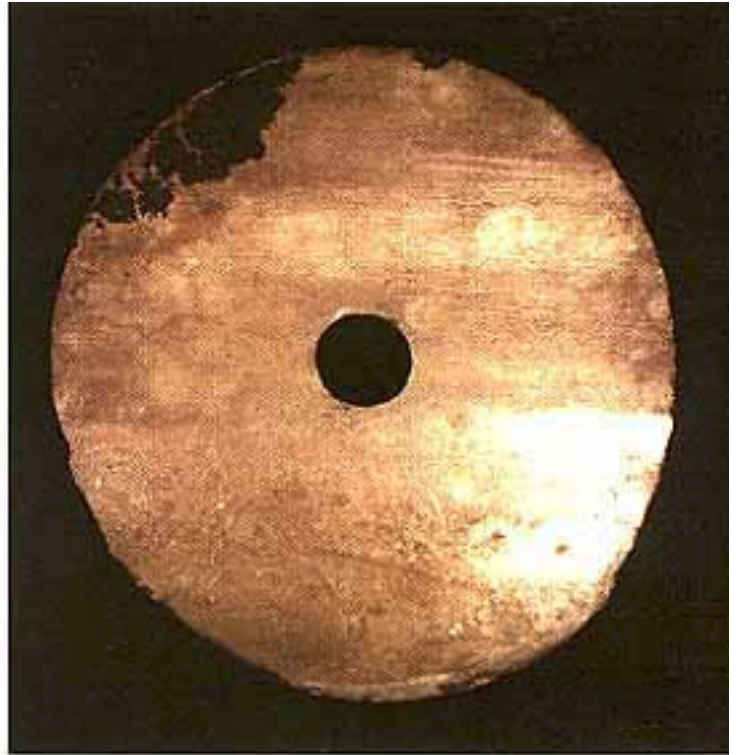
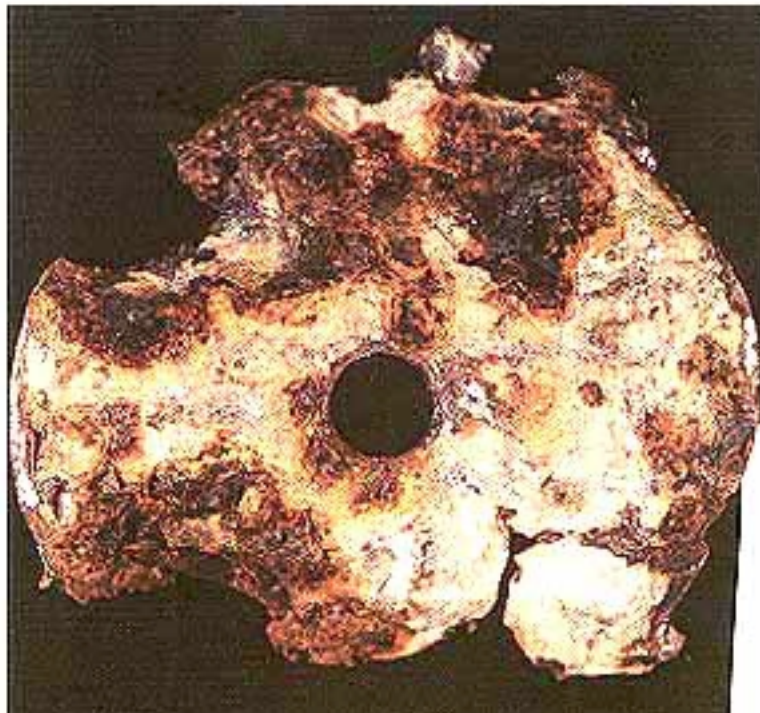
**Figure 6:** Comparative behavior of 43-year-old ALUMINIZED Type 2 and galvanized pipe in Marshall County, IA

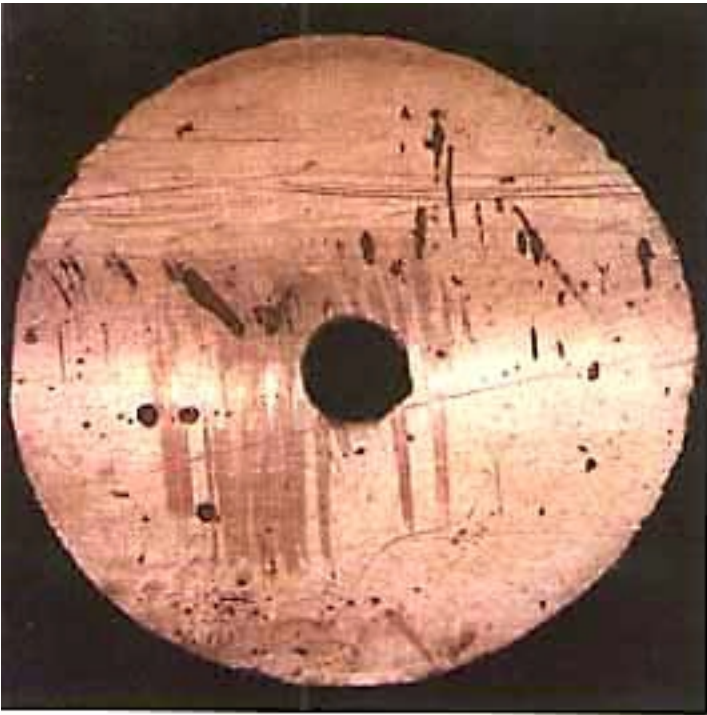
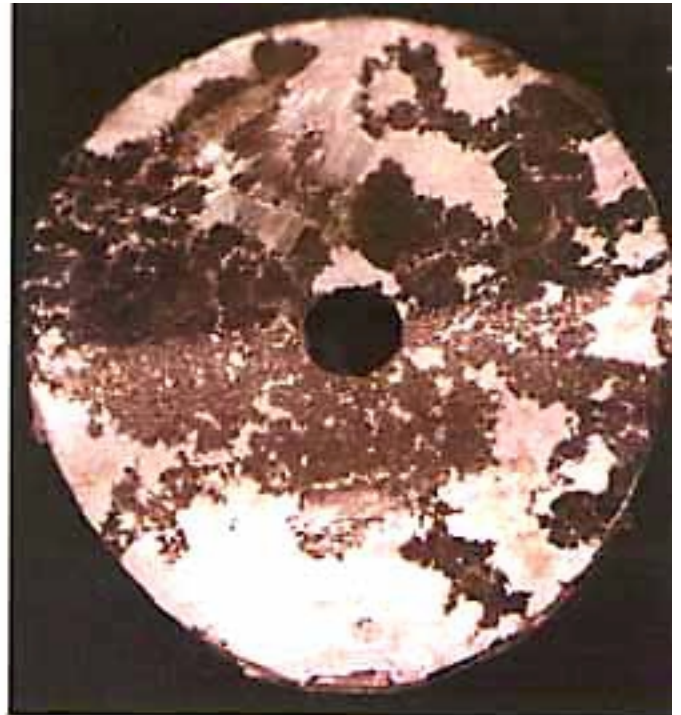
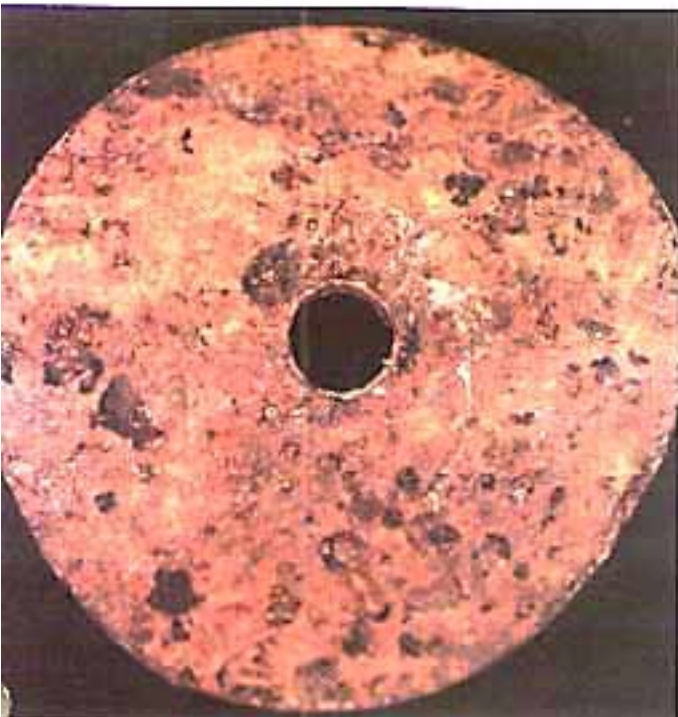
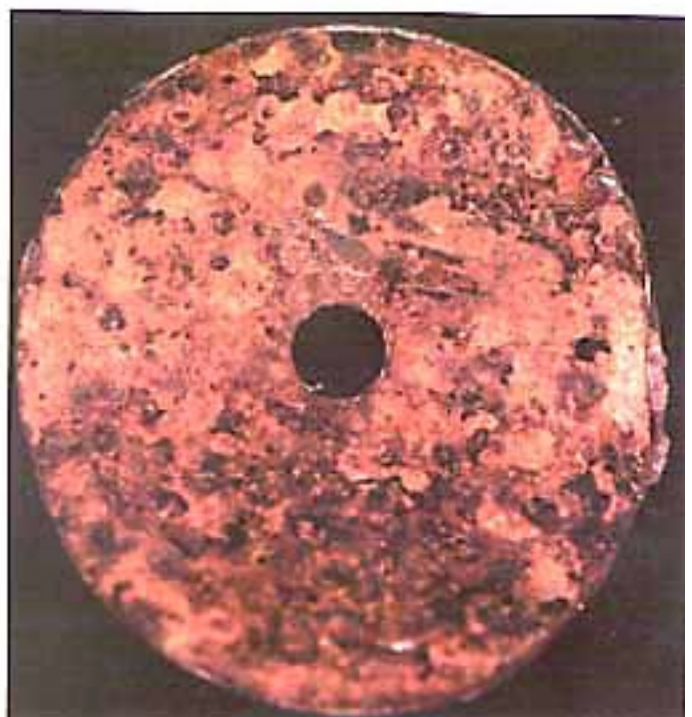
over galvanized will be realized. In milder environments, very long exposure times are required to verify the degree of Type 2 aluminized superiority, but trends indicate that the degree of superiority drops somewhat as galvanized behavior improves notably so that both materials give good longer-term life (see Figure 7). In milder environments where galvanized service life is projected to be 50+ years, Type 2 aluminized service life should clearly be far in excess of 75 years (at 16 gage). In overly severe environments too far outside the recommended environmental limits of pH or resistivity (pH 5-9 and resistivity  $\geq 1500$  ohm x cm), past studies have shown that superiority may be minimal with neither material performing satisfactorily<sup>(4)</sup>.

**Figure 7: Comparative behavior of 43-year-old ALUMINIZED Type 2 and galvanized pipe in relatively mild El Dorado County, CA site**

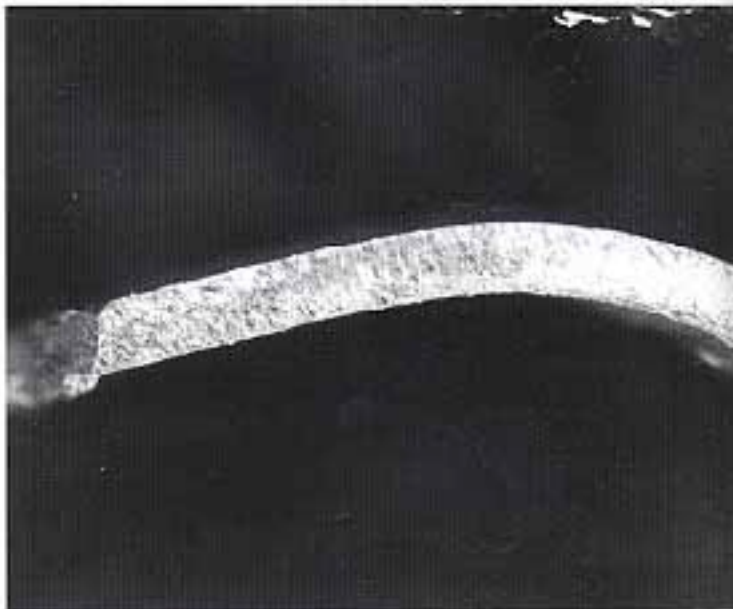
**Figure 8:** Comparative behavior of 43-year-old ALUMINIZED Type 2 and galvanized pipe in San Benito County, CA, under mild abrasive conditions on a roadway adjacent to a moderately steep embankment. Bottom half of coring is upslope side of corrugation crest.

**ALUMINIZED Type 2**  
Invert Cross-Section  
(No thickness loss)

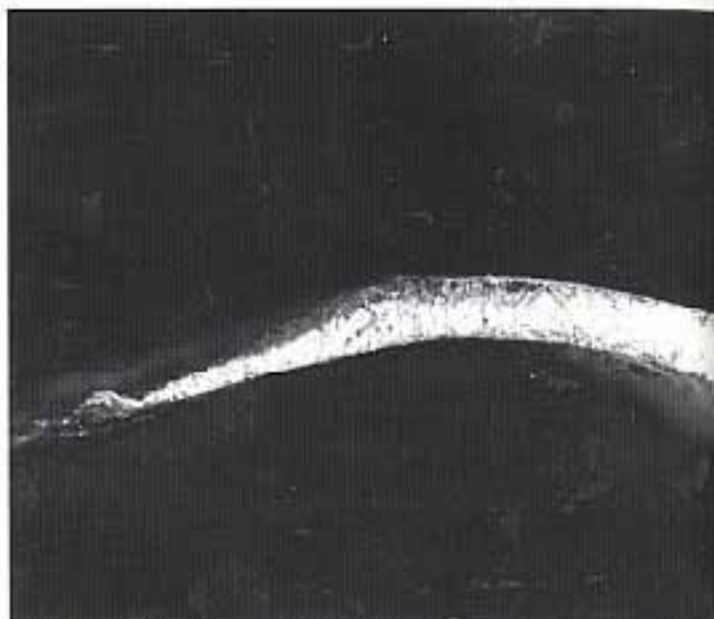
**Galvanized**  
Invert Cross-Section  
(Abrasive thinning on upslope side  
of corrugation crests)

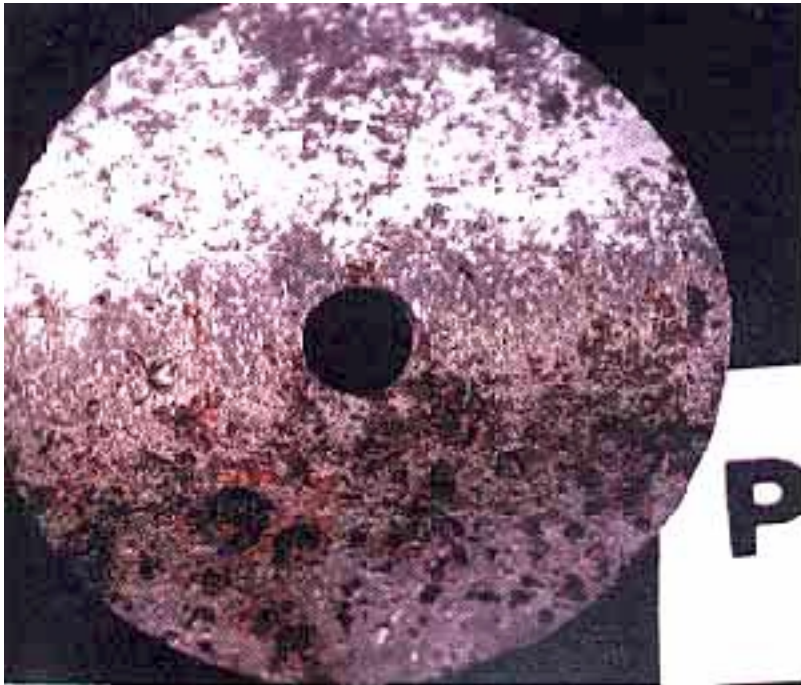
Studies of others have shown the superiority of Type 2 aluminized abrasion resistance<sup>(5)</sup>, and in our present survey as in our past one, we identified certain sites that demonstrated the Type 2 superior abrasion/erosion performance over that of galvanized steel (see Figures 8-9).

**Figure 9:** Comparative behavior of 43-year-old ALUMINIZED Type 2 and galvanized pipe in Carter County, MO, under relatively severe abrasive conditions on a roadway adjacent to a steep embankment. Bottom half of coring is upslope side of corrugation crest.

**ALUMINIZED Type 2**  
Invert - Waterside  
(Shallow abrasion-induced pits)

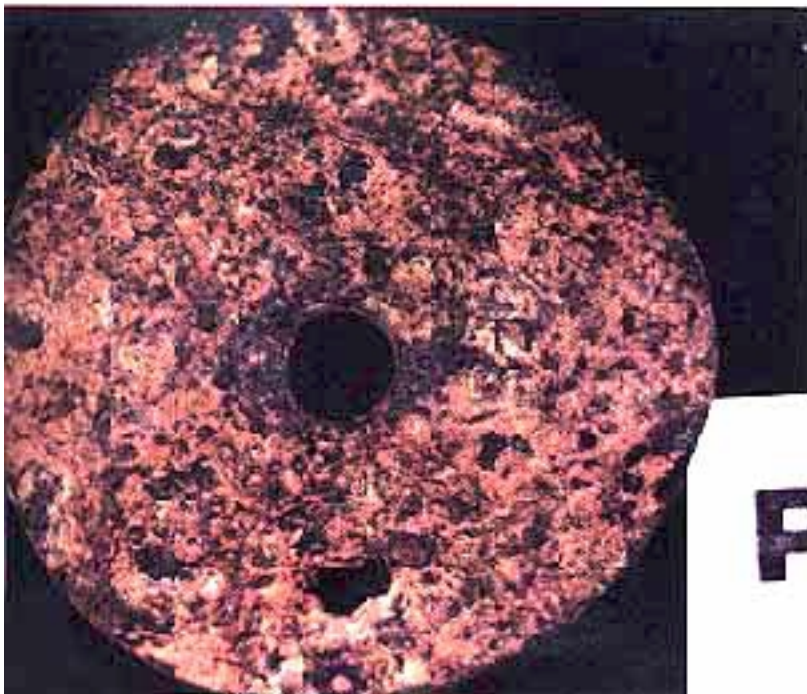
**Galvanized**  
Invert - Waterside  
(Perforated by abrasion)

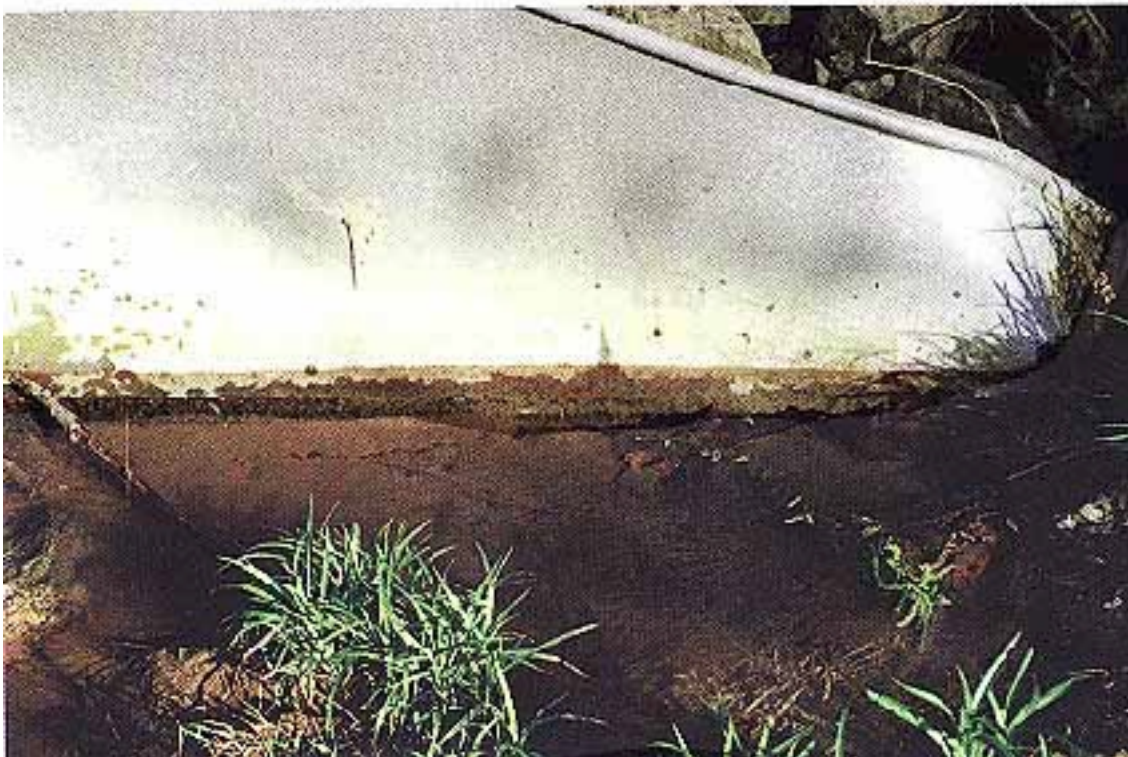
**Figure 10:** Comparative behavior of 15-year-old modern ALUMINIZED Type 2 pipe and galvanized end section in Montgomery County, MD

**Galvanized**  
**End Section**  
**(Widely perforated**  
**throughout up to**  
**waterline - grass**  
**growing through)**

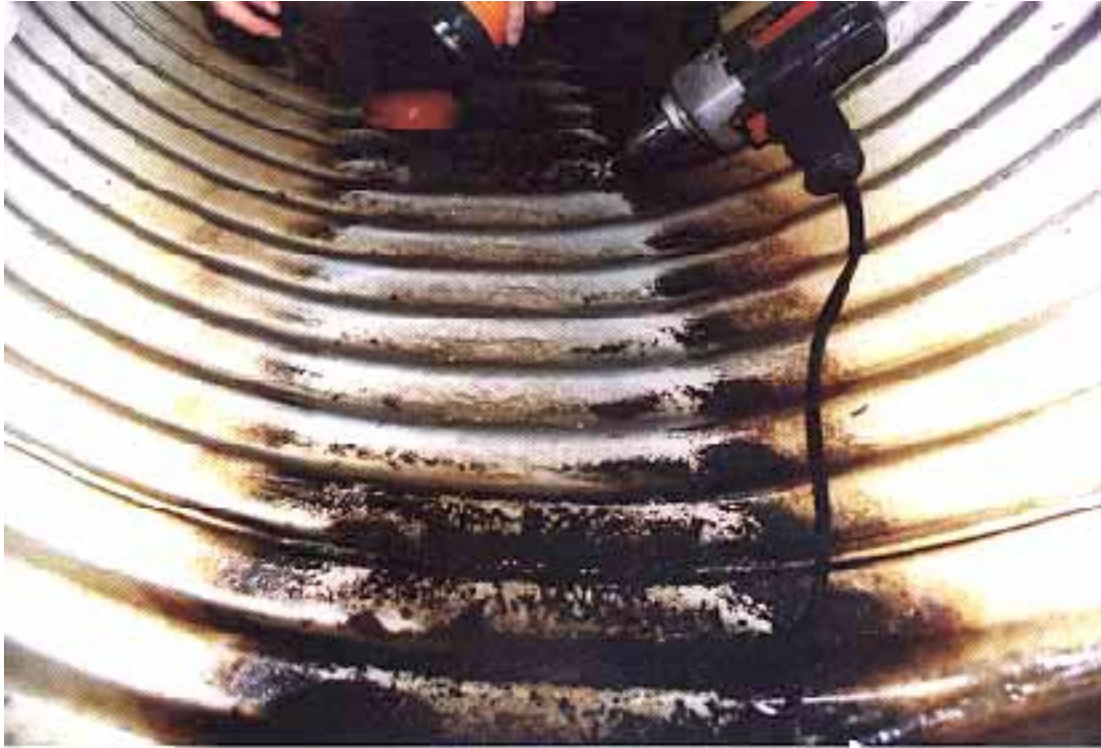
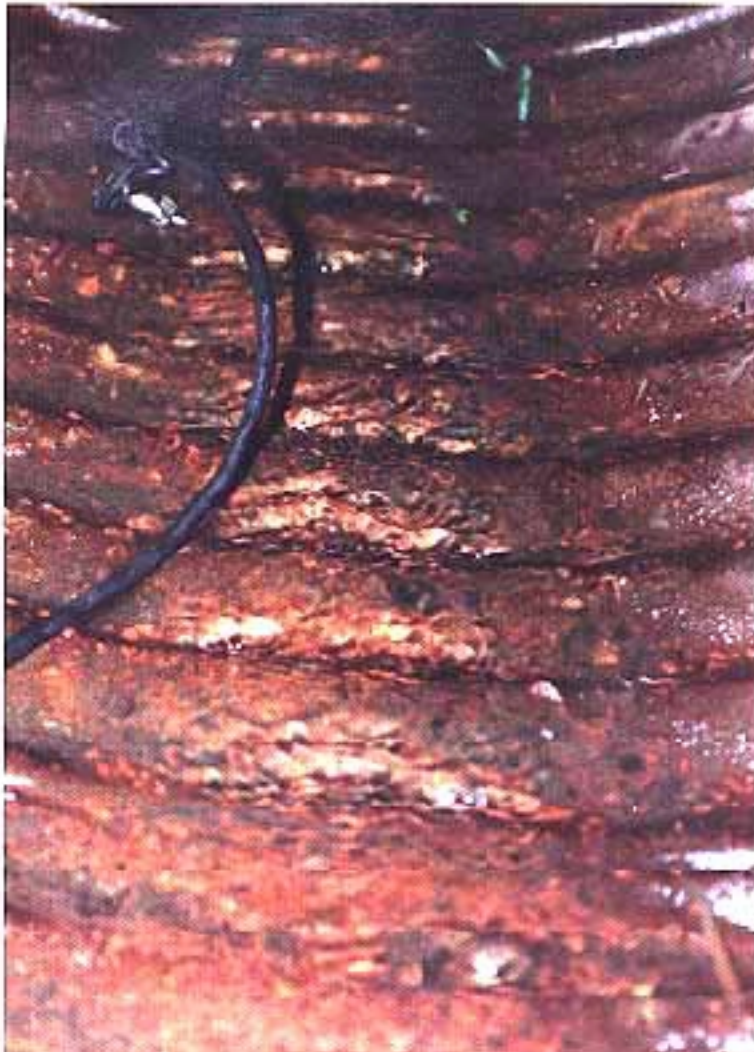
**Figure 11:** Comparative behavior of 10-year-old modern ALUMINIZED Type 2 and galvanized pipe at same site in Penobscot County, ME

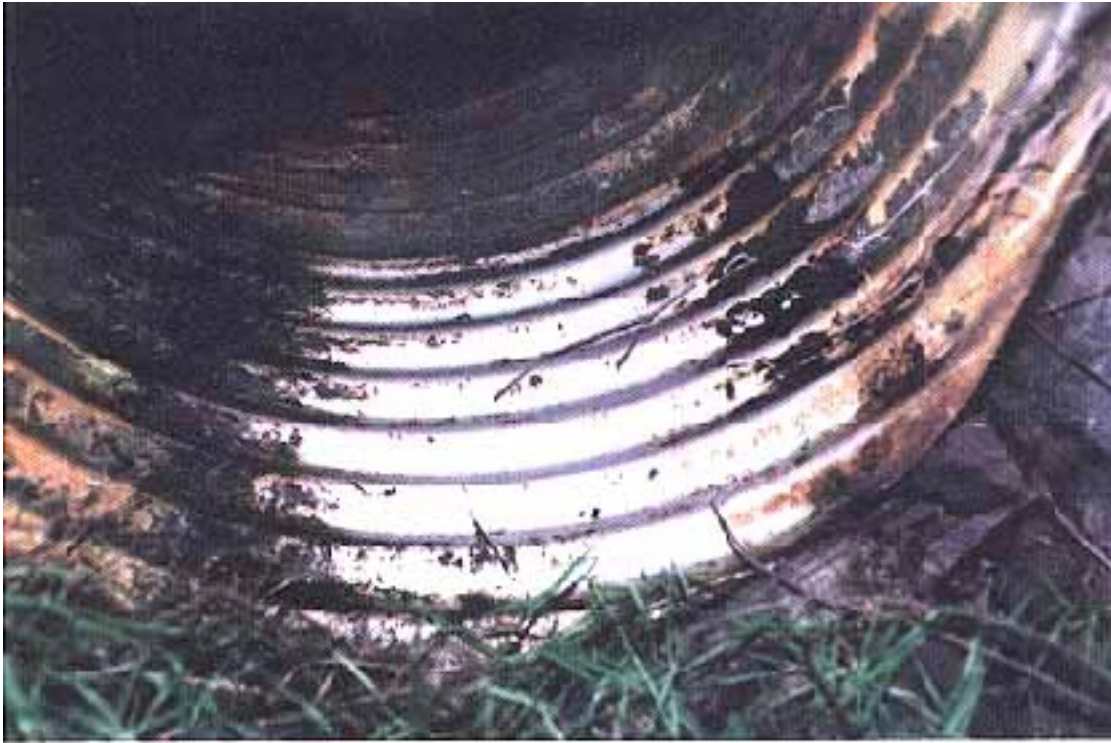
**Snohomish County, WA**  
14-year-old ALUMINIZED Type 2 pipe is performing comparably with 42-year-old riveted Type 2 pipe with which it was joined in tandem 14 years ago.

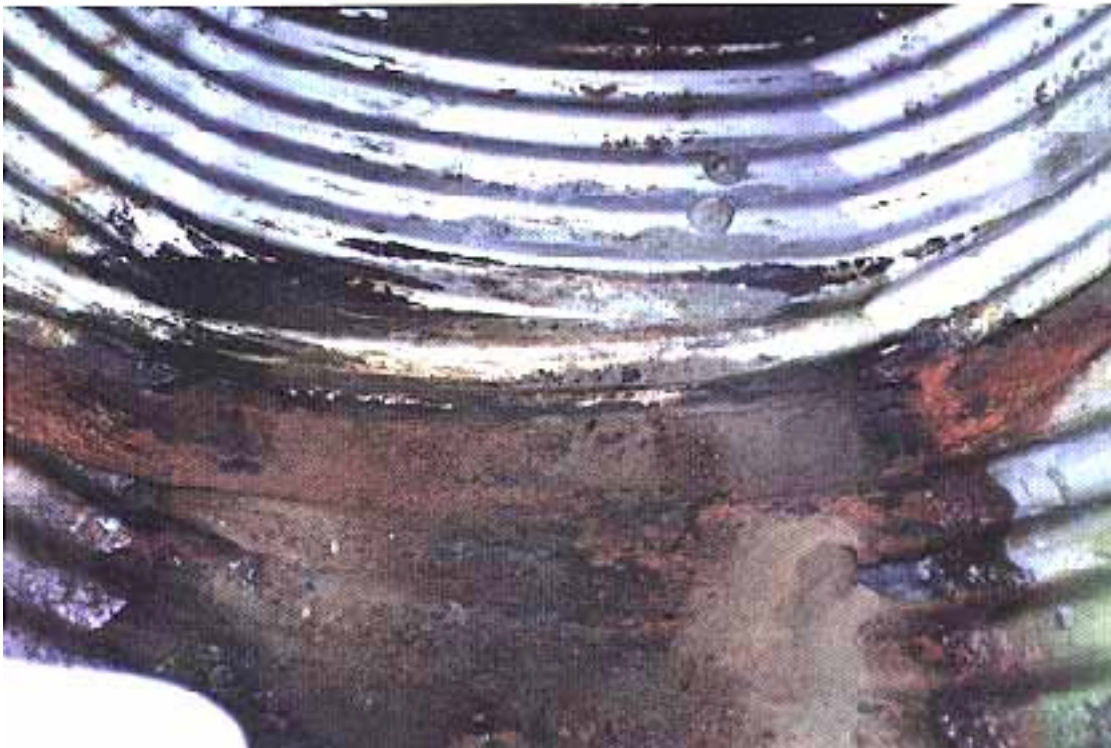
**Gwinnett County, GA**  
10-year-old ALUMINIZED Type 2 pipe and headwall galvanized pipe stub with galvanized coupling band.

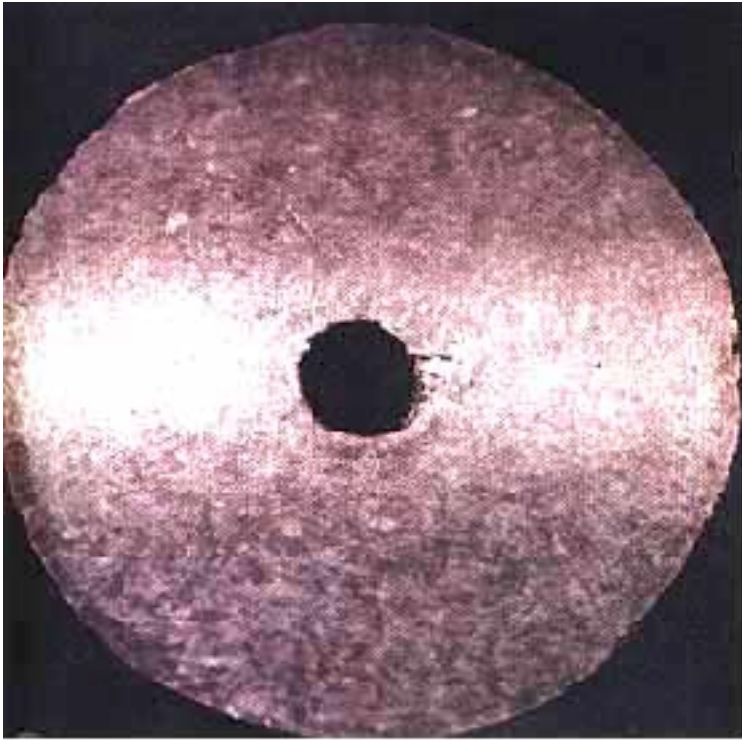
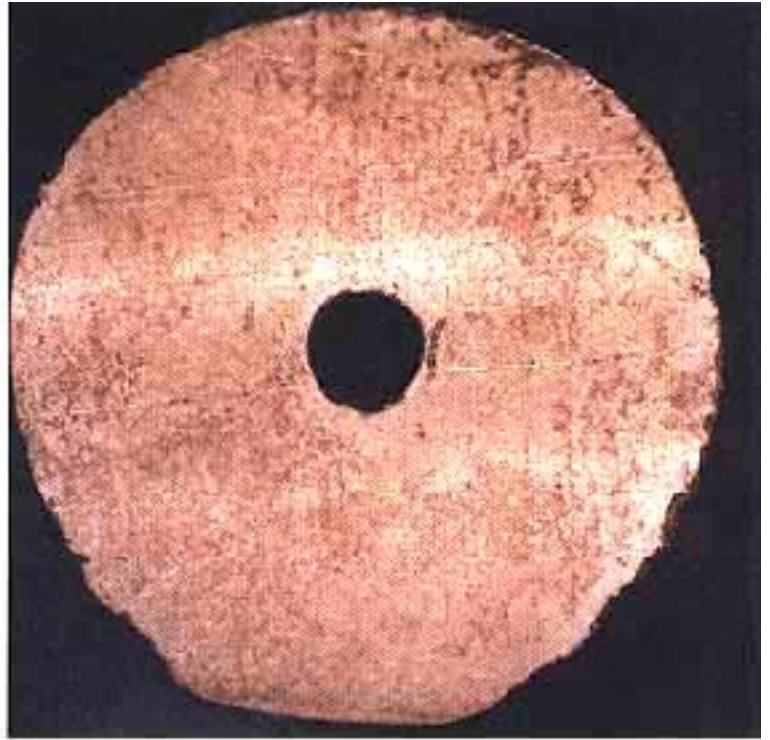
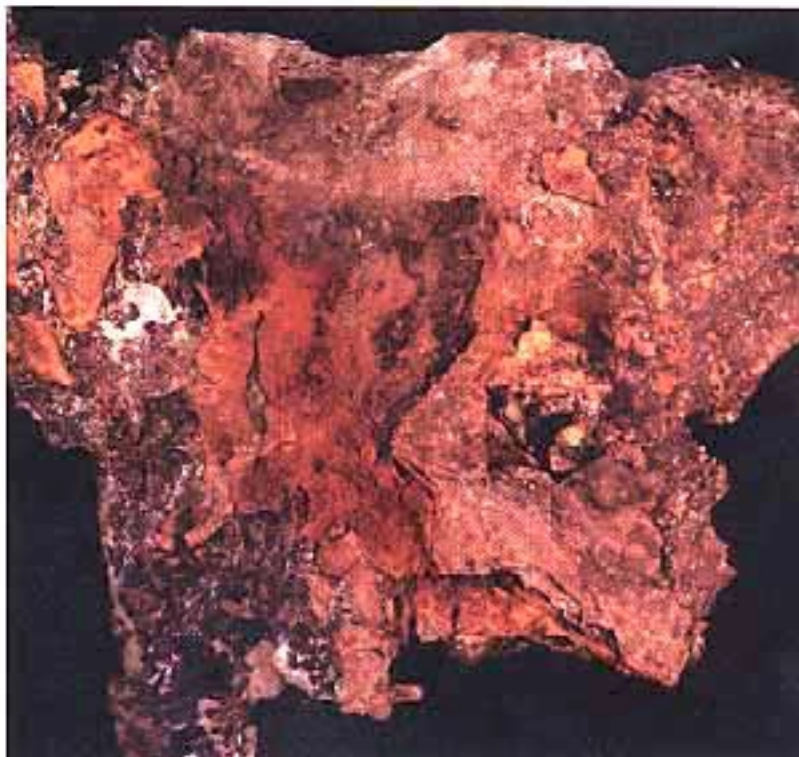
**Figure 13: Comparative behavior of 15-year-old modern ALUMINIZED Type 2 pipe and galvanized end section in Montgomery Co., MD**

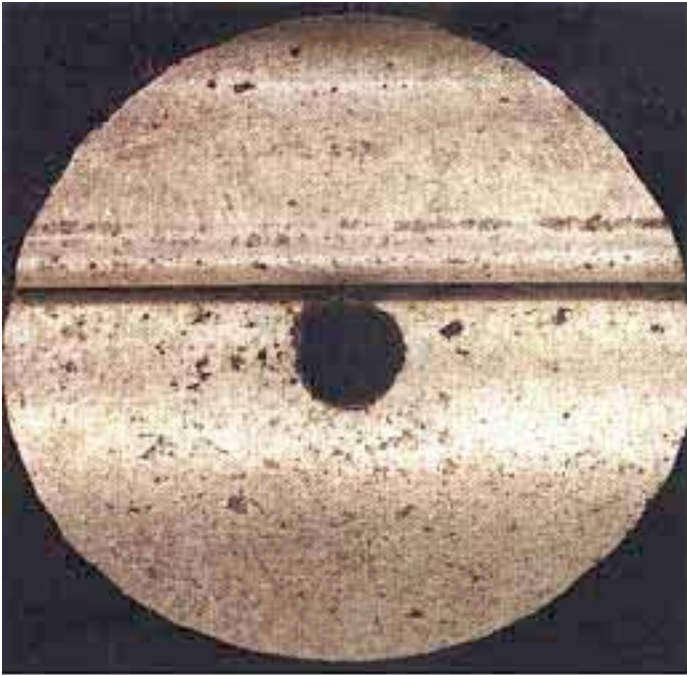
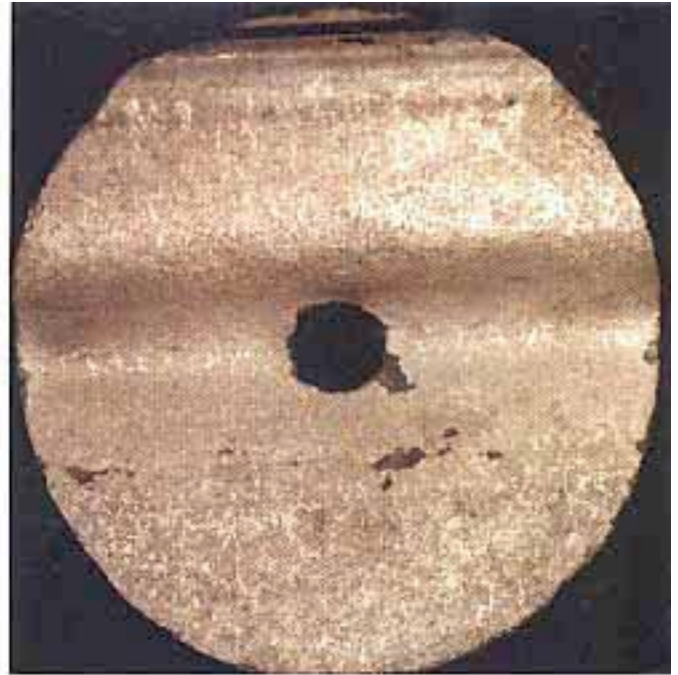
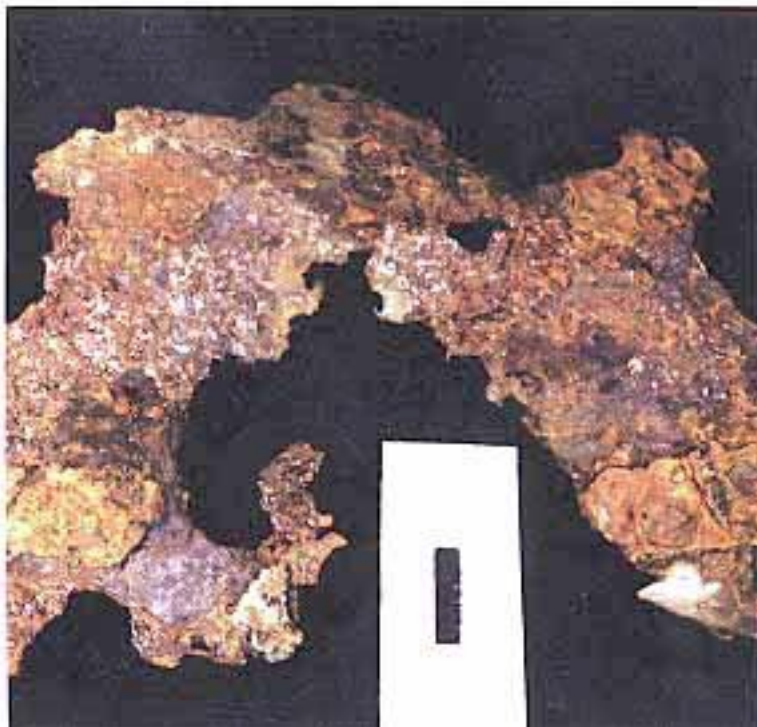
**Figure 14:** Comparative behavior of 10-year-old ALUMINIZED Type 2 pipe and galvanized pipe in Penobscot Co., ME
