## **Heritage Marketplace Field Evaluation:** *Stormwater Management StormFilter with CSF Leaf Media*

### **Introduction**

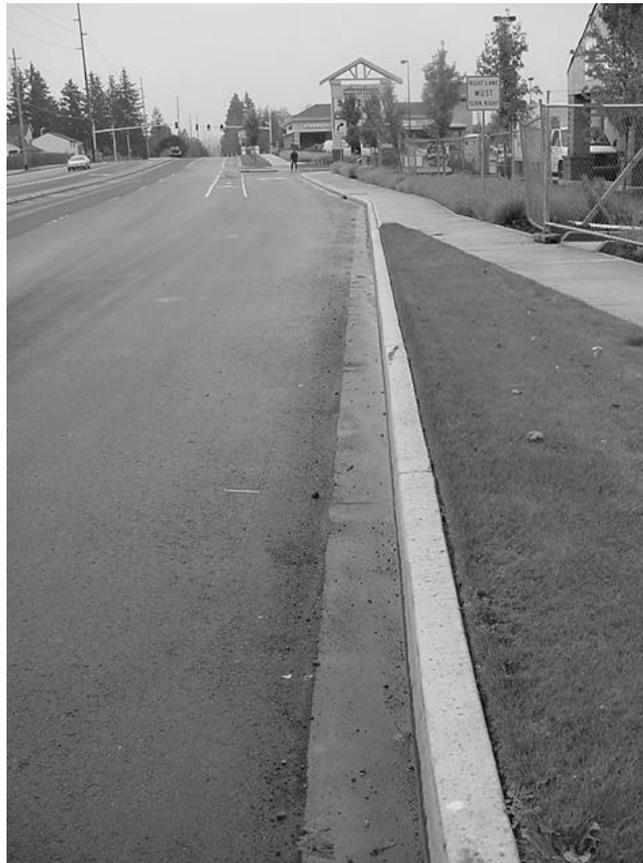
**Figure 1. View of part of the Heritage Marketplace site drainage area.**

The StormFilter system under evaluation is one of three systems installed at Heritage Marketplace. Heritage Marketplace is a busy shopping center anchored by a large supermarket and located at the intersection of NE 4<sup>th</sup> Plain Road and NE 162<sup>nd</sup> Avenue, Clark County, WA (N 45° 40.249, W 122° 30.368). The StormFilter system treats runoff from 4.0 acres of impervious surface. Primary sources of pollution within this drainage area include solids, metals, and oil from automobiles and their tires, and organic matter from landscaping. 40-ft upstream of the StormFilter system is a 7.0-ft by 5.5-ft pre-settling vault with a storage volume of 1,500-gal and a down-turned outlet pipe that is designed to remove some of the heavier solids from the stormwater runoff prior to filtration by the StormFilter system.

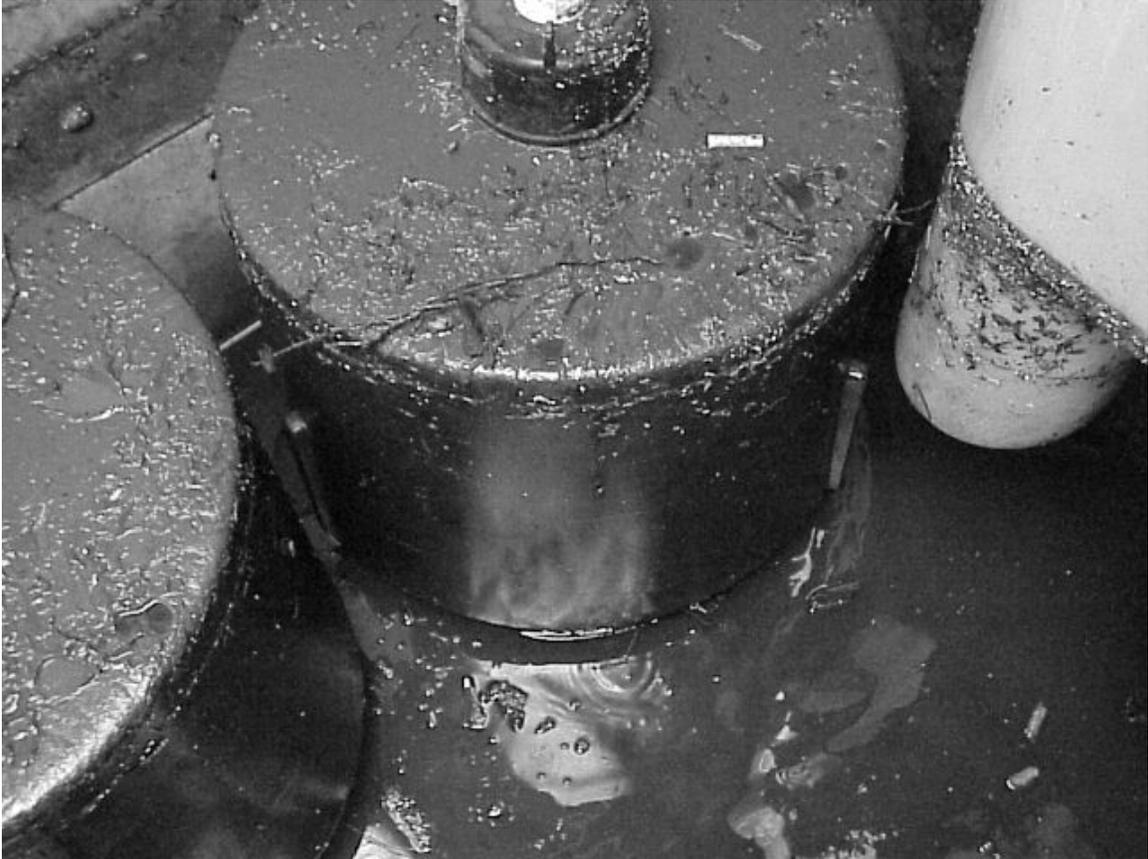
**Figure 2. Evidence of low-density solids within the StormFilter system. Notice the floating solids as well as the solids visible on the tops and sides of the StormFilter cartridges as well as the sides of the overflow scum baffle (white object in upper right of picture).**

As mentioned, Heritage Marketplace is a busy shopping center that receives a large volume of traffic on a daily basis. This is evidenced by the high concentrations of influent TSS. These concentrations are unusually high given the presence of a pre-settling vault upstream of the influent sampling point, which should capture the heavier solids. Visual observations of the samples associated with the 4/26/02 event indicated an abundance of low-density, organic particles. To confirm this observation, Total Volatile Solids (TVS) analysis was added to the analysis list for samples from the 5/17/02 event, indicating that 59% of the particulate matter leaving the pre-settling vault and entering the StormFilter system was volatile and thus assumed to be organic. The organic, low density nature of the materials entering the StormFilter system most likely explains their ability to evade capture by the pre-settling vault.

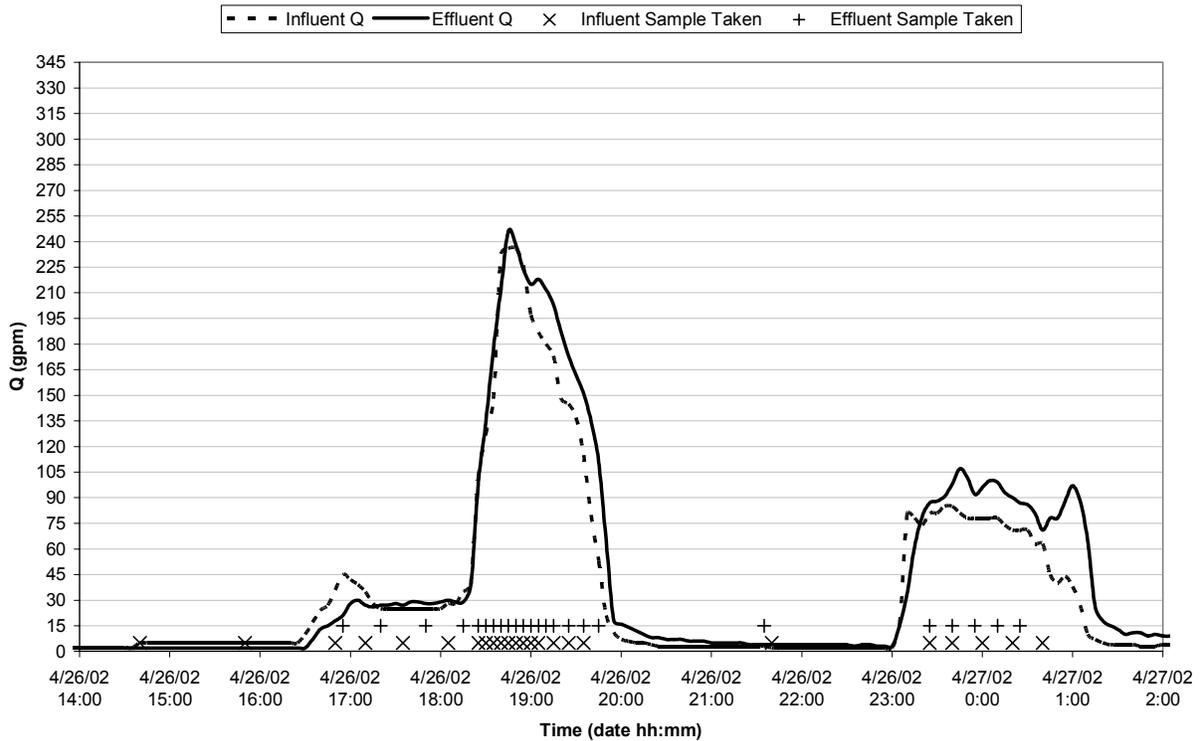
**Event Hydrograph**

Site: Heritage Marketplace (2270), Vancouver, WA  
 System Description: 8x16 vault, CSF, 23 cartridges @ 15 gpm  
 Event Date: 4/26/02 to 4/27/02  
 Date of Last Maintenance: 4/27/01  
 Antecedent Conditions: 10 days since last rain event

Total Precipitation (in): 0.24  
 Peak Flow, Influent (gpm): 236  
 Peak Flow, Effluent (gpm): 246  
 Total Runoff Volume (gal): 26925

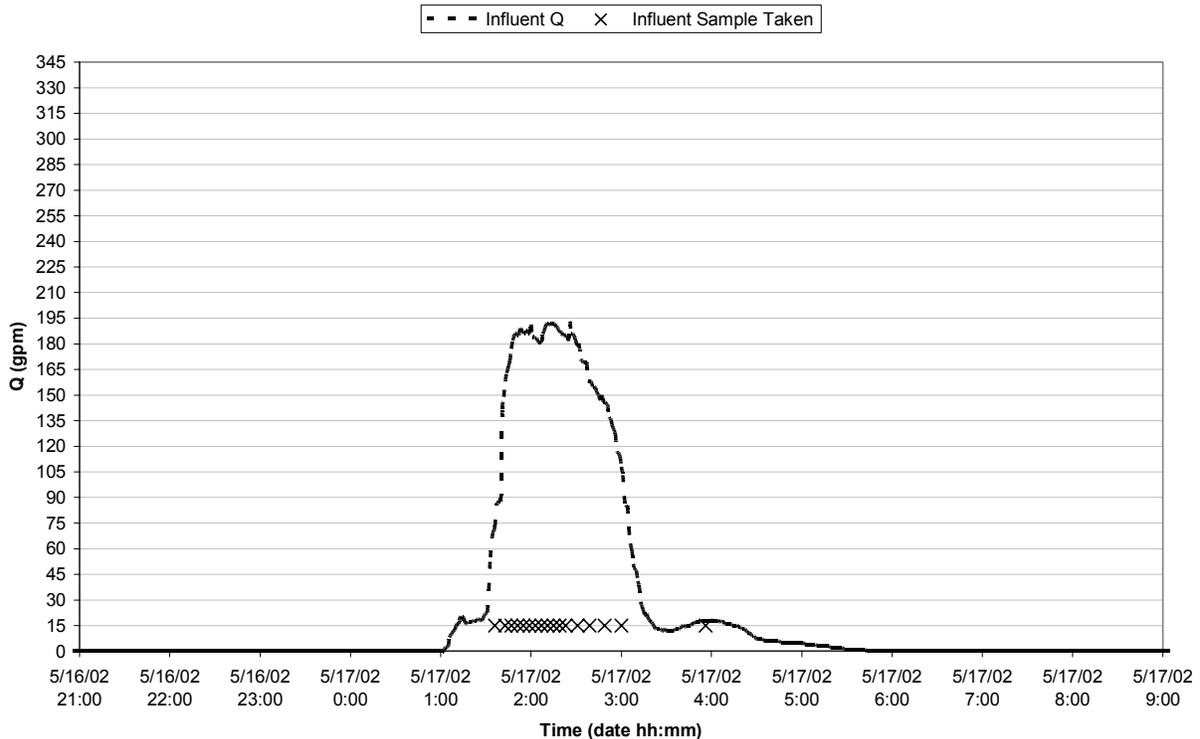
**Event Hydrograph**

Site: Heritage Marketplace (2270), Vancouver, WA  
 System Description: 8x16 vault, CSF, 23 cartridges @ 15 gpm  
 Event Date: 5/17/02  
 Date of Last Maintenance: 4/27/01  
 Antecedent Conditions: 2 days since last rain event

Total Precipitation (in): 0.16  
 Peak Flow, Influent (gpm): 190  
 Peak Flow, Effluent (gpm): ---  
 Total Runoff Volume (gal): 16921

Only one flow probe was used; influent and effluent samples were paced by the influent flow. Shaded Dup. RPD values defaulted to 20% standard due to QC complications.

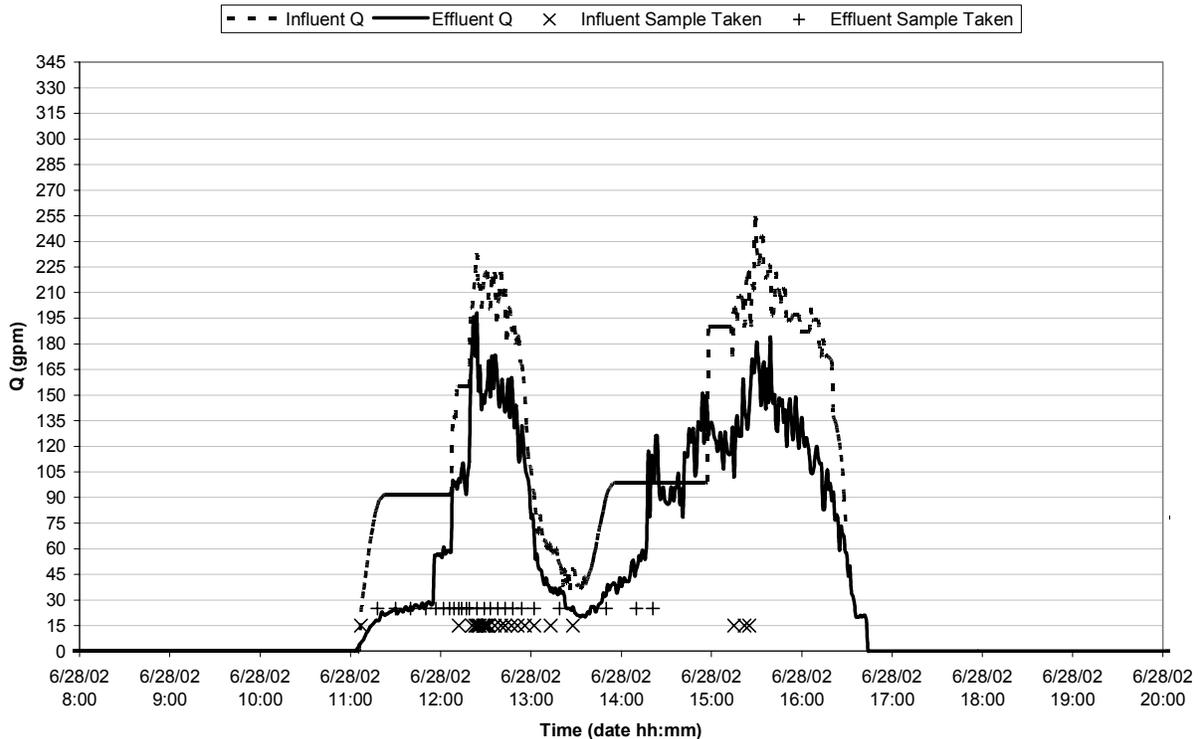
**Event Hydrograph**

Site: Heritage Marketplace (2270), Vancouver, WA  
 System Description: 8x16 vault, CSF, 23 cartridges @ 15 gpm  
 Event Date: 6/28/02  
 Date of Last Maintenance: 4/27/01  
 Antecedent Conditions: 9 days since last rain event

Total Precipitation (in): 0.82  
 Peak Flow, Influent (gpm): 254  
 Peak Flow, Effluent (gpm): 198  
 Total Runoff Volume (gal): 42047
