**ALUMINIZED STEEL TYPE 2 CORRUGATED  
STEEL PIPE DURABILITY UPDATE: 1995**

**FIELD PERFORMANCE OF PIPES IN  
SERVICE FOR 42-43 YEARS**

**February 8, 1996**

**LAWRENCE BEDNAR  
SENIOR STAFF CORROSION ENGINEER  
PRODUCT RESEARCH  
RESEARCH & TECHNOLOGY  
AK STEEL CORPORATION**

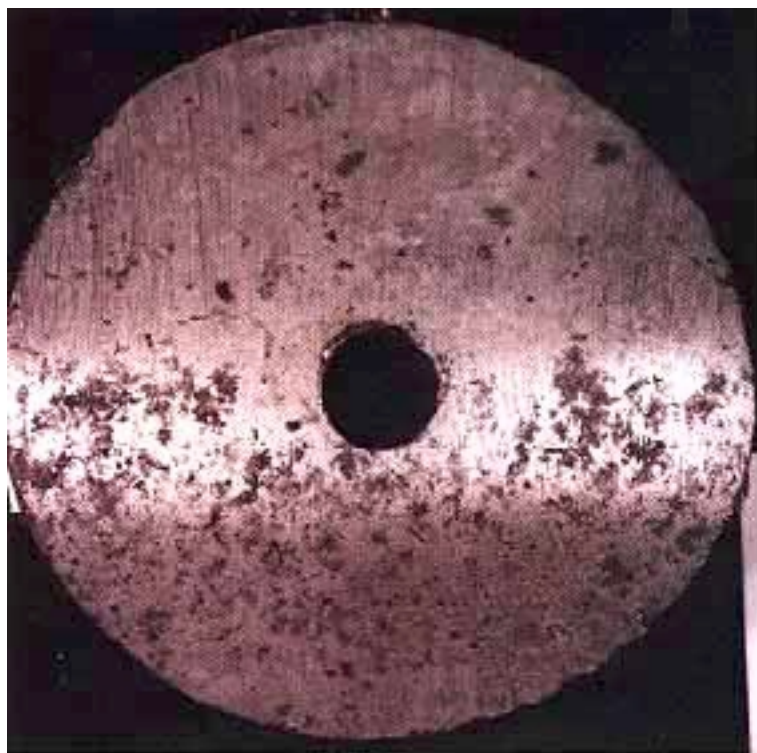
**Figure 8:** Comparative behavior of 43-year-old ALUMINIZED Type 2 and galvanized pipe in San Benito County, CA, under mild abrasive conditions on a roadway adjacent to a moderately steep embankment. Bottom half of coring is upslope side of corrugation crest.

**ALUMINIZED Type 2**  
Invert - Waterside

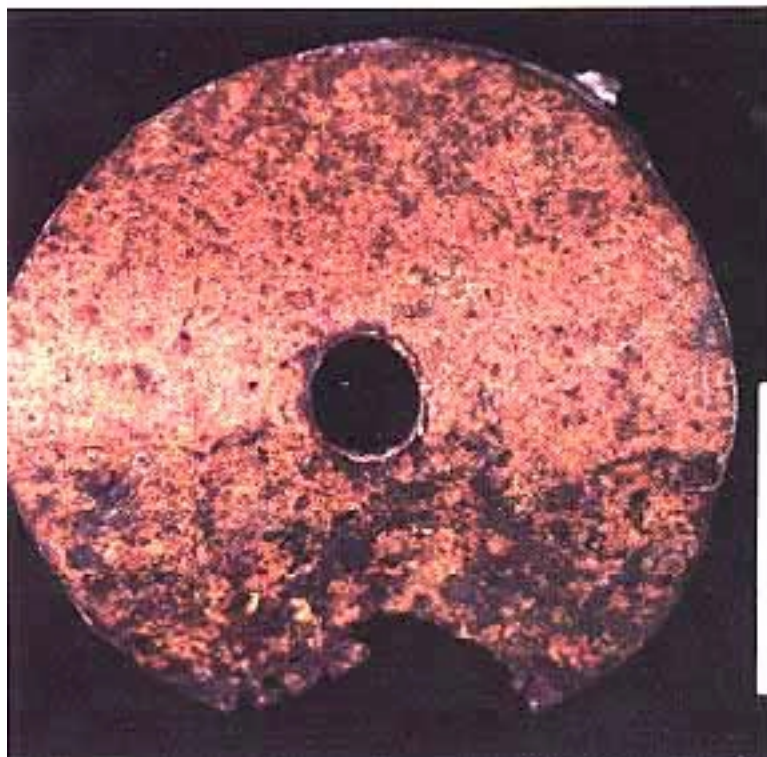
**Galvanized**  
Invert - Waterside

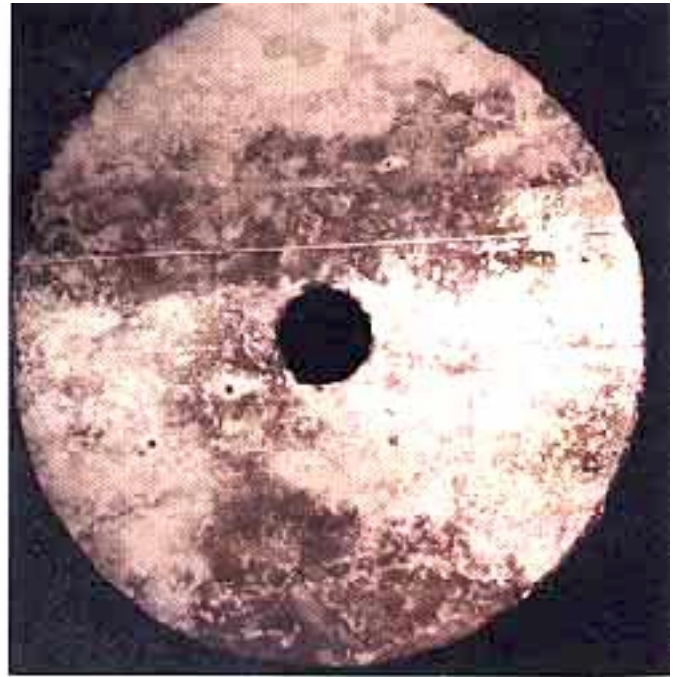
**Figure 9:** Comparative behavior of 43-year-old ALUMINIZED Type 2 and galvanized pipe in Carter County, MO, under relatively severe abrasive conditions on a roadway adjacent to a steep embankment. Bottom half of coring is upslope side of corrugation crest.

**ALUMINIZED Type 2**  
Invert - Soilside

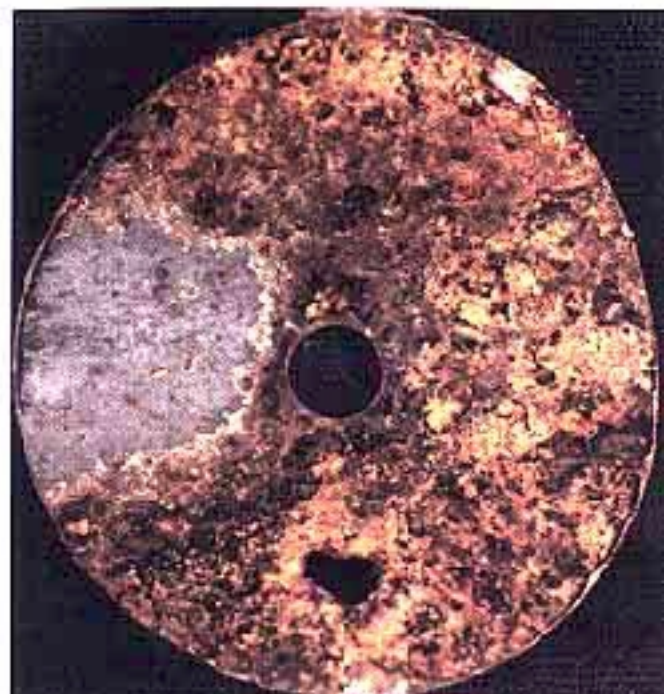
**Galvanized**  
Invert - Soilside

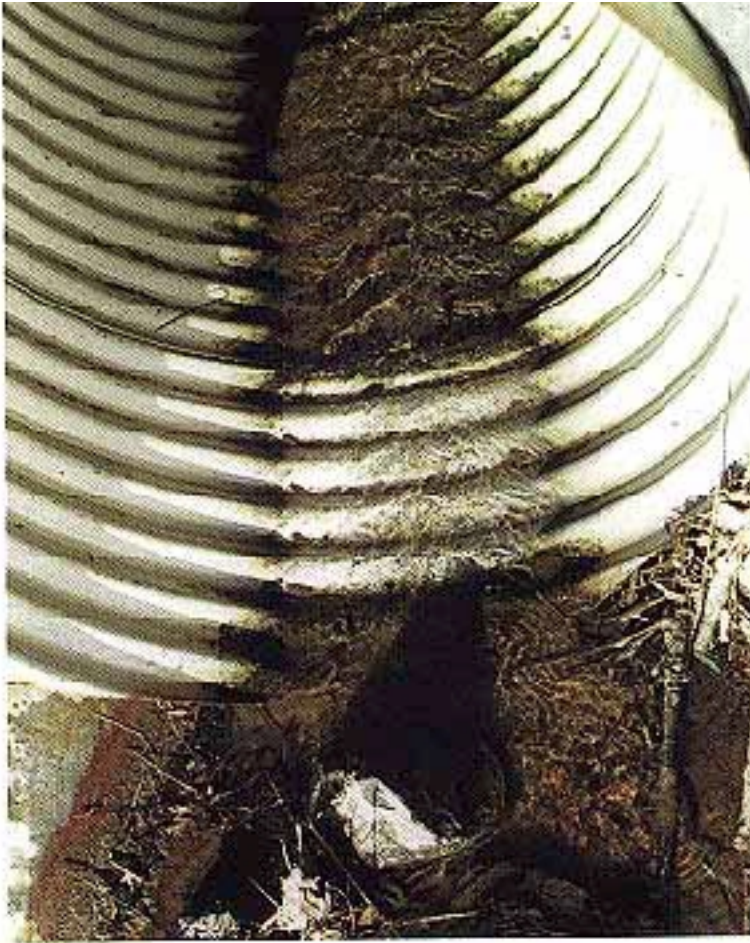
**Figure 10:** Comparative behavior of 15-year-old modern ALUMINIZED Type 2 pipe and galvanized end section in Montgomery County, MD

**ALUMINIZED Type 2**  
**Pipe**
