Snap-Tite® Culvert Lining System

The no-dig trenchless solution.

The Snap-Tite® HDPE Lining System is ideal for failing metal and concrete culverts.

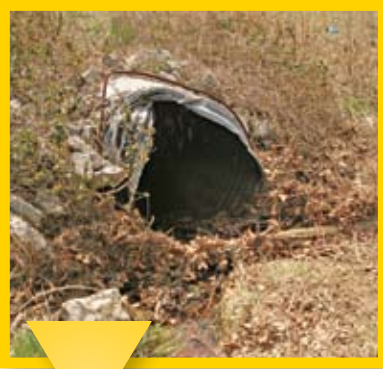
A typical deteriorated culvert close to failure, potentially leading to road collapse and danger to the motoring public.

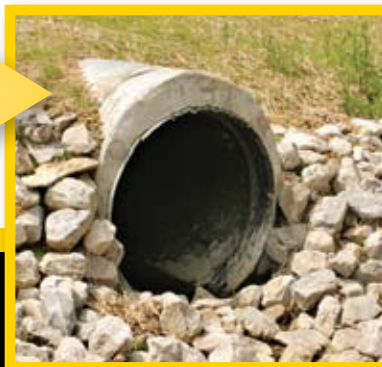
The same culvert, excavated and prepared for Snap-Tite® rehab. Since the pipe was so deteriorated, this project required the installation of a corrugated metal sleeve to accept the new pipe. A concrete footer was also poured.

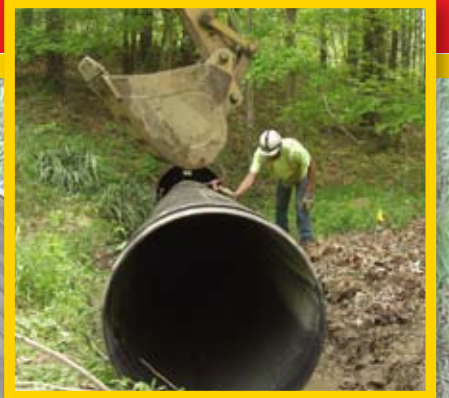
The first piece of Snap-Tite® HDPE is lowered into position and inserted into the host pipe.

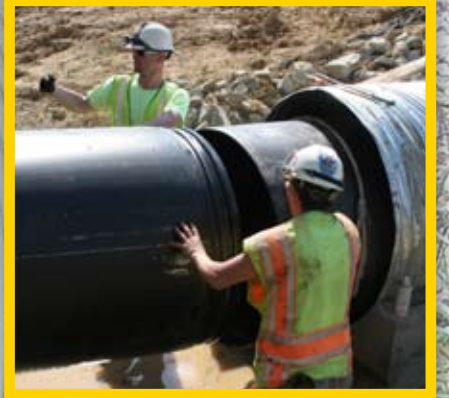
A gasket is installed on the next piece of pipe, assuring a watertight seal when connected, meeting ASTM D3212 requirements.
